Manhole Inspection Summary

Manhole # S29Q1_022MH

Insp Date: **2/15/08 8:57 AM**

Location Address: **2997 Spelman Road**

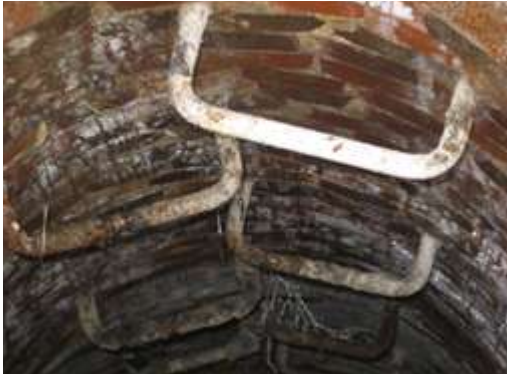
Count: **8** Missing: **0** ☒ **Corroded**

steps

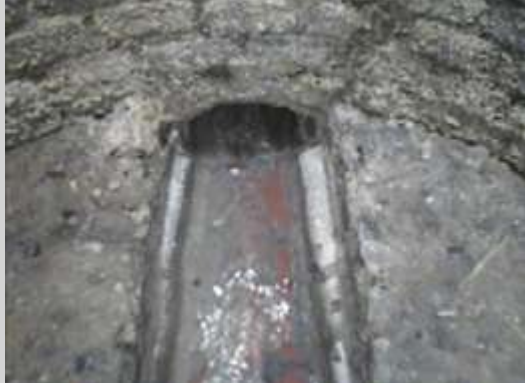
12 O'Clock Outflow

8 in. Circular Gravity Sewer
Pipe Out @ 12 O'Clock

Pipe Height: **9.6** (in.) Rod and Bar (Angled)
Pipe Material: **Clay** ☐ Pipe Lined
Invert Depth: **11.79** (ft.) Flow Characteristics: **Slow**
Deposits: ☒ None ☐ Mud ☐ Sludge ☐ Debris ☐ Grease
Silt Depth: (in.) Deposits Extent:
Infiltration: **None** Pipe Seal Cond: **Sound**

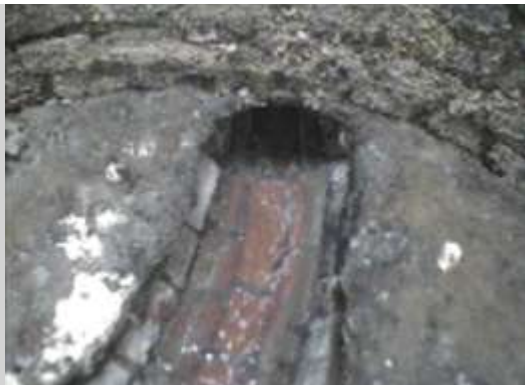
3 O'Clock Inflow

8 in. Circular Service Sewer
Pipe In @ 3 O'Clock

Pipe Height: **9.6** (in.) Rod and Bar (Angled)
Pipe Material: **Clay** ☐ Pipe Lined
Invert Depth: **11.69** (ft.) Flow Characteristics: **Slow**
Deposits: ☒ None ☐ Mud ☐ Sludge ☐ Debris ☐ Grease
Silt Depth: (in.) Deposits Extent:
Infiltration: **None** Pipe Seal Cond: **Sound**

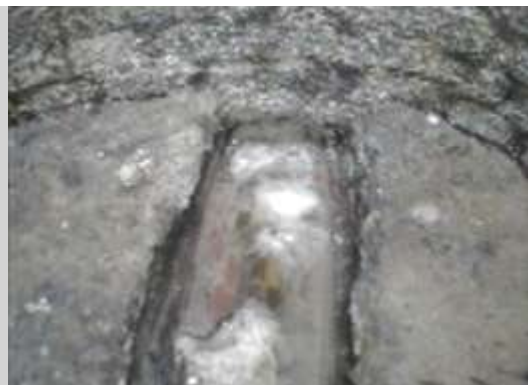
6 O'Clock Inflow

8 in. Circular Gravity Sewer

Pipe In @ 6 O'Clock

Pipe Height: **7.2** (in.) Rod and Bar (Angled)

Infiltration: **None** Pipe Seal Cond: **Sound**
